Chuitna Coal Project Mine Site Lakes Preliminary Water Quality Assessment Summary Report

April 16, 2010

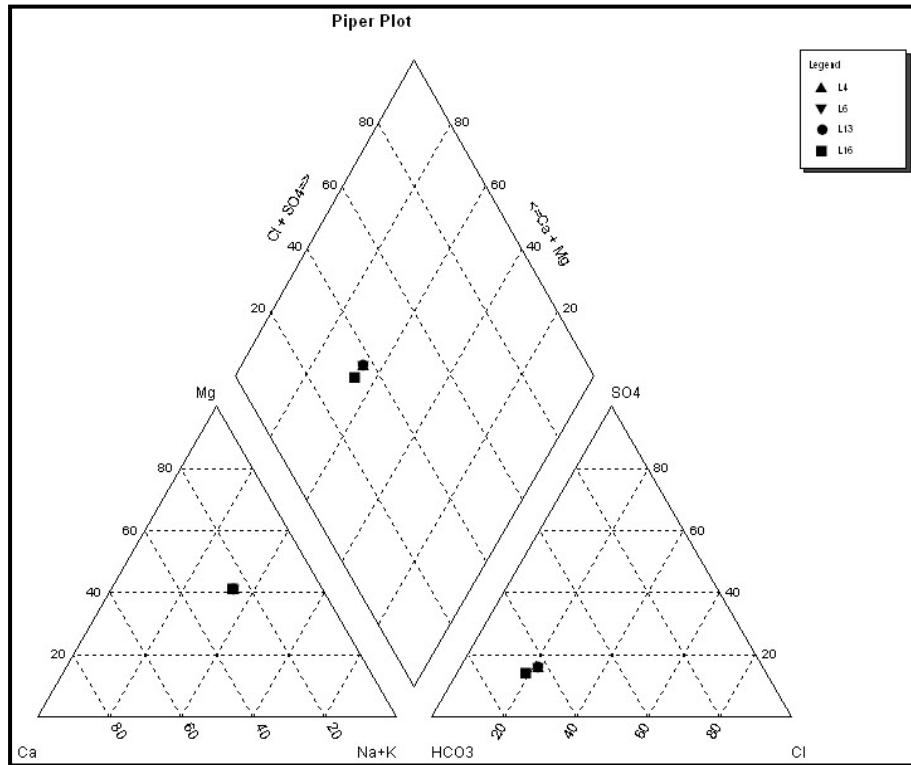
Figure 6a – Piper Diagram – Lake Samples

Figure 6a presents a Piper Diagram showing the major anions and cations for the lake samples. The clustering shown on the Piper Diagram indicates that there is not much spatial variability in the lake water quality for this sampling event. The pattern demonstrated by the Piper Diagram is consistent with the surface waters and ground waters in the area (Riverside 2009, Riverside 2010). Results of past surface water samples is shown on the Piper Diagram in Figure 6b for comparison.

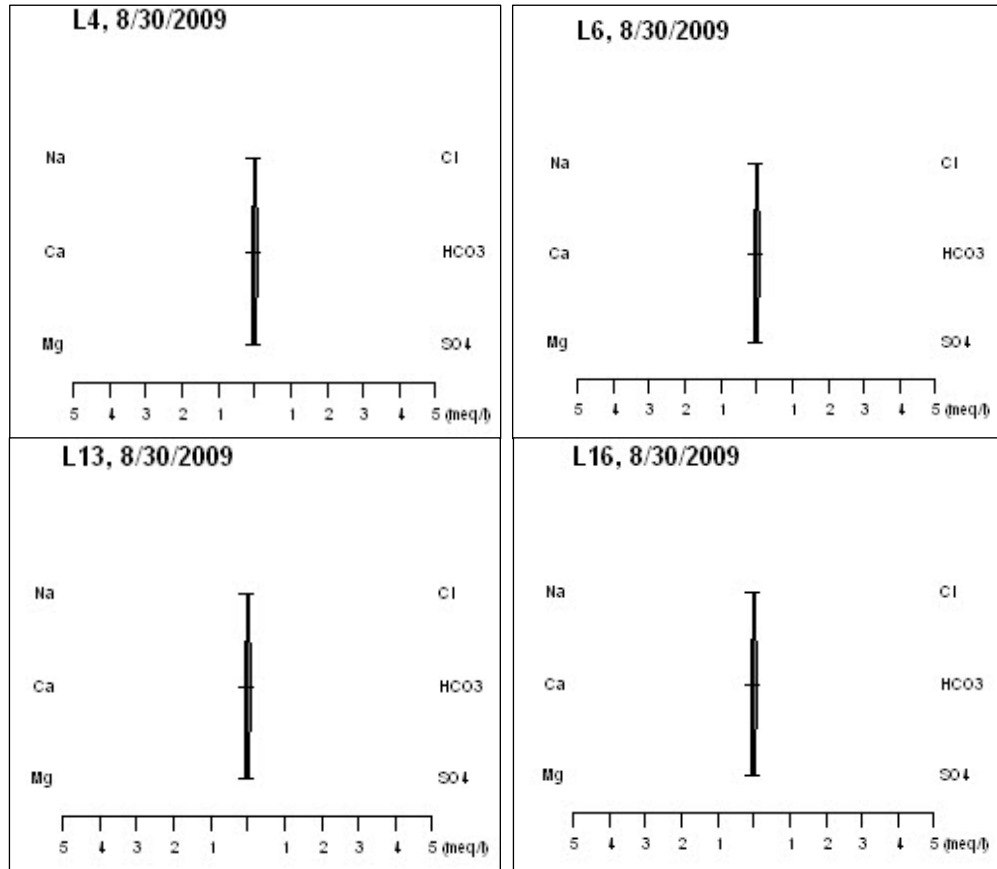
Figure 7 - Stiff Diagrams

Figure 7 presents Stiff diagrams for the lake samples. The ion concentrations are low in all samples, but the waters appear to be bicarbonate with very low levels of calcium and sodium. There is little to no variation between the lakes for this sampling event. The lake water for this sampling event demonstrates lower ion concentrations than typically found in the surface waters and ground waters in the area (Riverside 2009, Riverside 2010).
